Manhole Inspection Summary

Manhole # S19C1_013MH

Insp Date: **5/29/08 1:05 PM**

Location Address: **1964 sponson st**

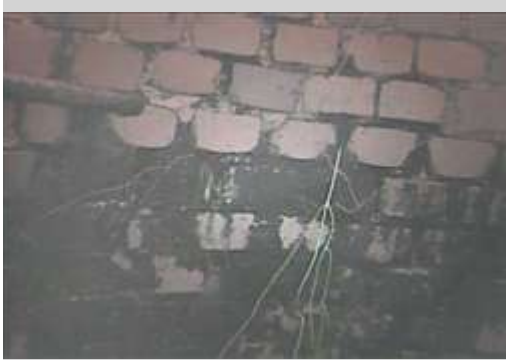
Defect 5

Condition: ☐ Sound ☐ Cracked ☒ **Root Intrusion** ☐ Loose Brick ☐ Deteriorated

root intrusion @ corbel wall

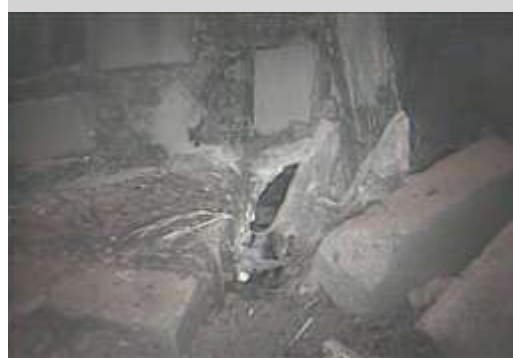
Defect 6

Condition: ☐ Sound ☐ Cracked ☐ Root Intrusion ☐ Deteriorated ☐ Leaks ☒ **Debris**

Channel Debris

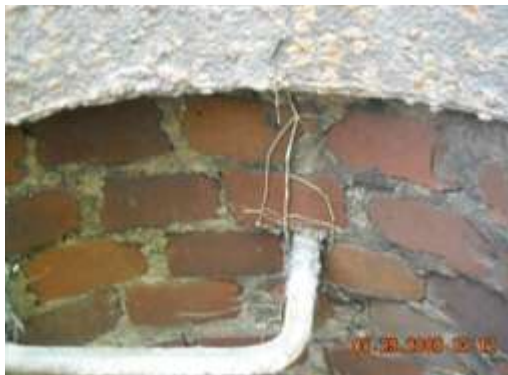
Defect 2

root intrusion @ frame/corbel joint

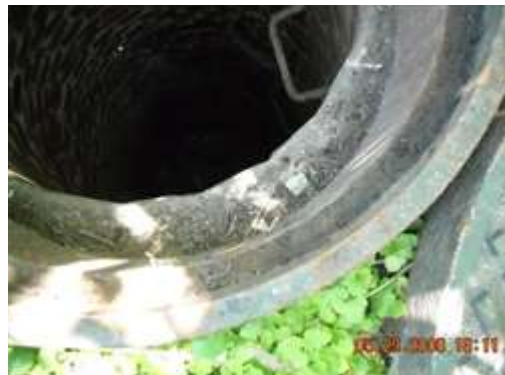
Defect 1

Offset: **2.5** (in.)

frame offset

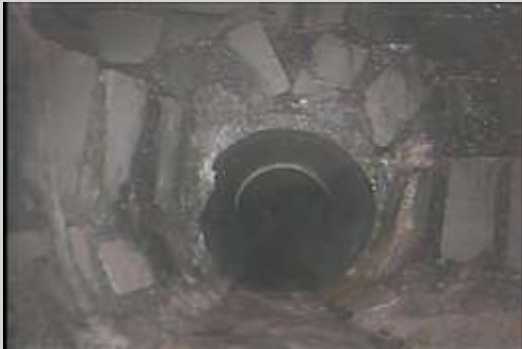
12 O'Clock Outflow

8 in. Circular Gravity Sewer
Pipe Out @ 12 O'Clock

Infiltration: **Evidence** Pipe Seal Cond: **Sound**

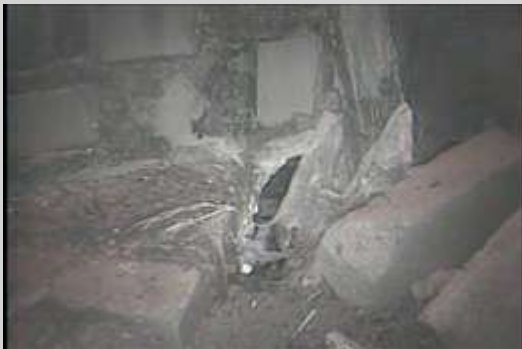
3 O'Clock Inflow

8 in. Circular Gravity Sewer
Pipe In @ 3 O'Clock

Deposits: ☐ None ☒ **Mud** ☐ Sludge ☒ **Debris** ☐ Grease

Silt Depth: **9** (in.) Deposits Extent: **Heavy**
